Coating Impact Fatigue Test

Phase II - Final Report

A study on PVD/CVD hard coatings for die wear protection by impact fatigue testing methodology

Project: ASP230. Project No.: 10-2338

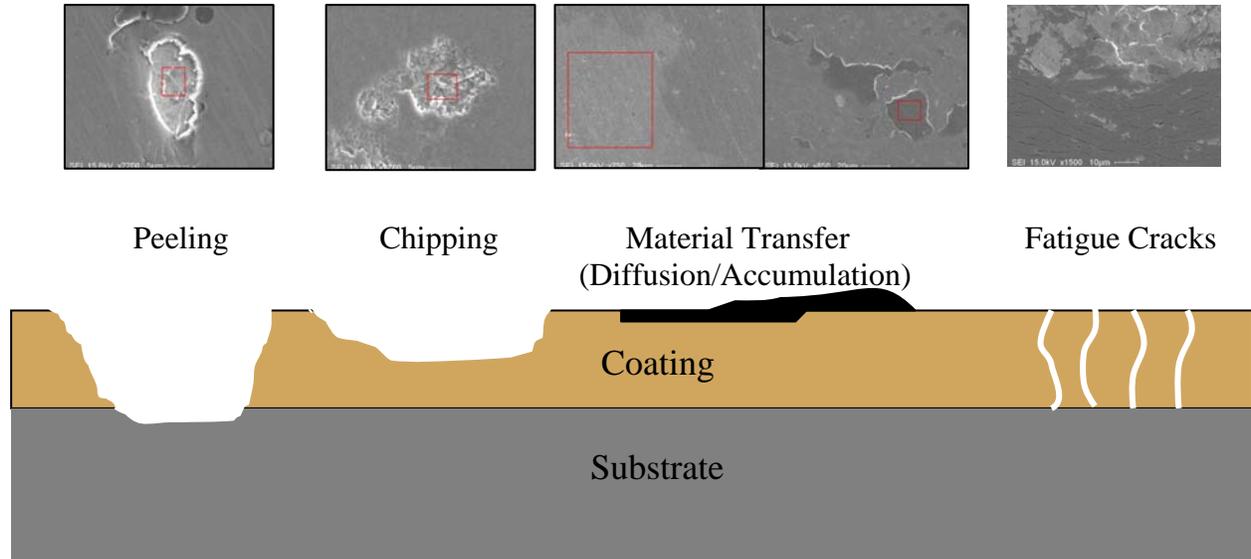
A schematic of these failures is given in Figure 5. The characterization of failure modes was based on the EDX analysis method as used in Phase I. All the coating failure mechanisms mentioned above could be observed in most cases. Fatigue cracks may be the main reason for the coatings to initiate cohesive and adhesive failures. For example, fatigue cracks may lead to chipping (cohesive failure) and peeling

(adhesive failure). Material transfer may be more severe at the spot where the surface became rough due to other failures. The locations where cohesive and adhesive failures occur may also in return act as initiation sites of fatigue cracking and as a result, the chipping and peeling areas increased at a fast path.

Figure 5: SEM images and Illustration of failure modes

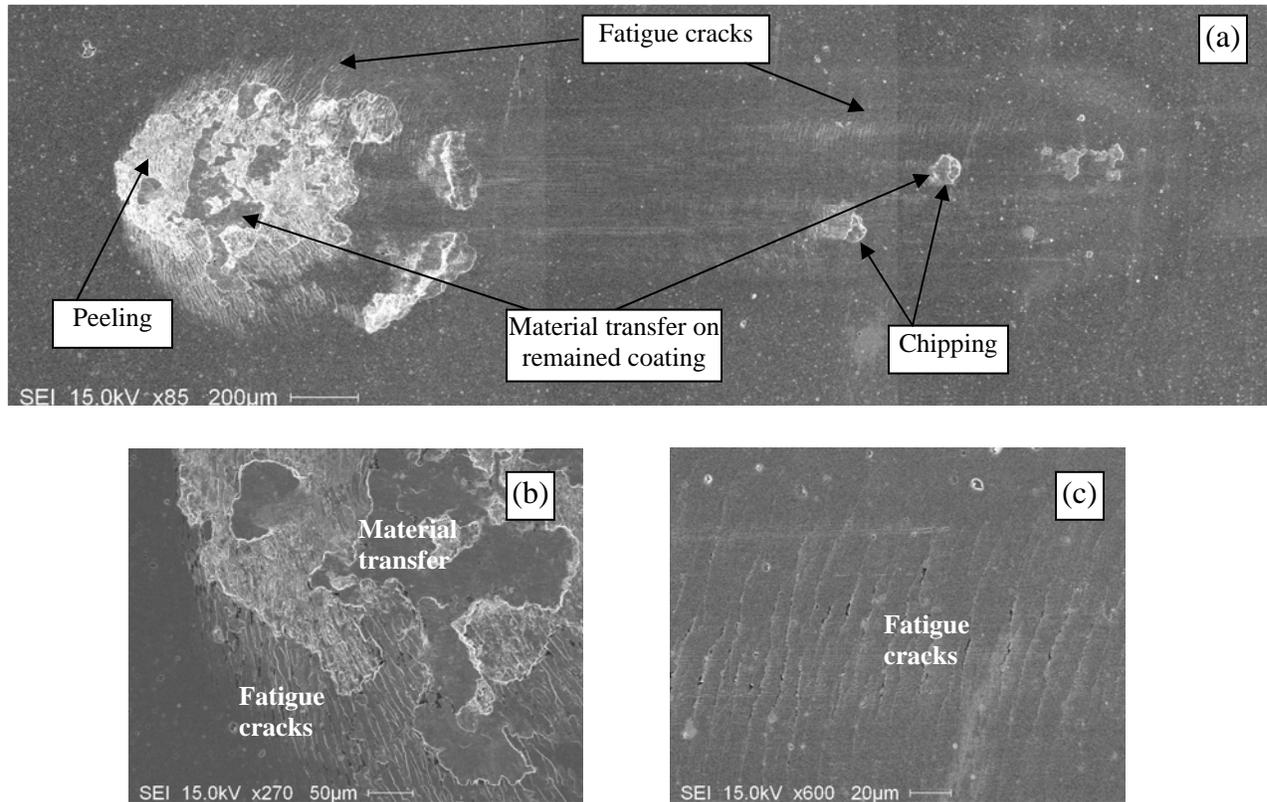
The A_TiAlN coating displayed all four primary failure mechanisms as shown in Figure 6. Peeling with surrounding chipping and fatigue cracks were found at the impact-induced crater. The TiAlN coating materials still existed at the center of the crater with Fe transferred from the steel ball. Fatigue cracks appeared at the boundary of the crater and along most of the sliding track as shown in Figure 6b and Figure 6c.

Figure 6: SEM images of the impact-sliding track of A_TiAlN after 1500 cycles
 (a) Overview; (b) fatigue cracks at the edge of the crater; (c) fatigue cracks in the sliding track

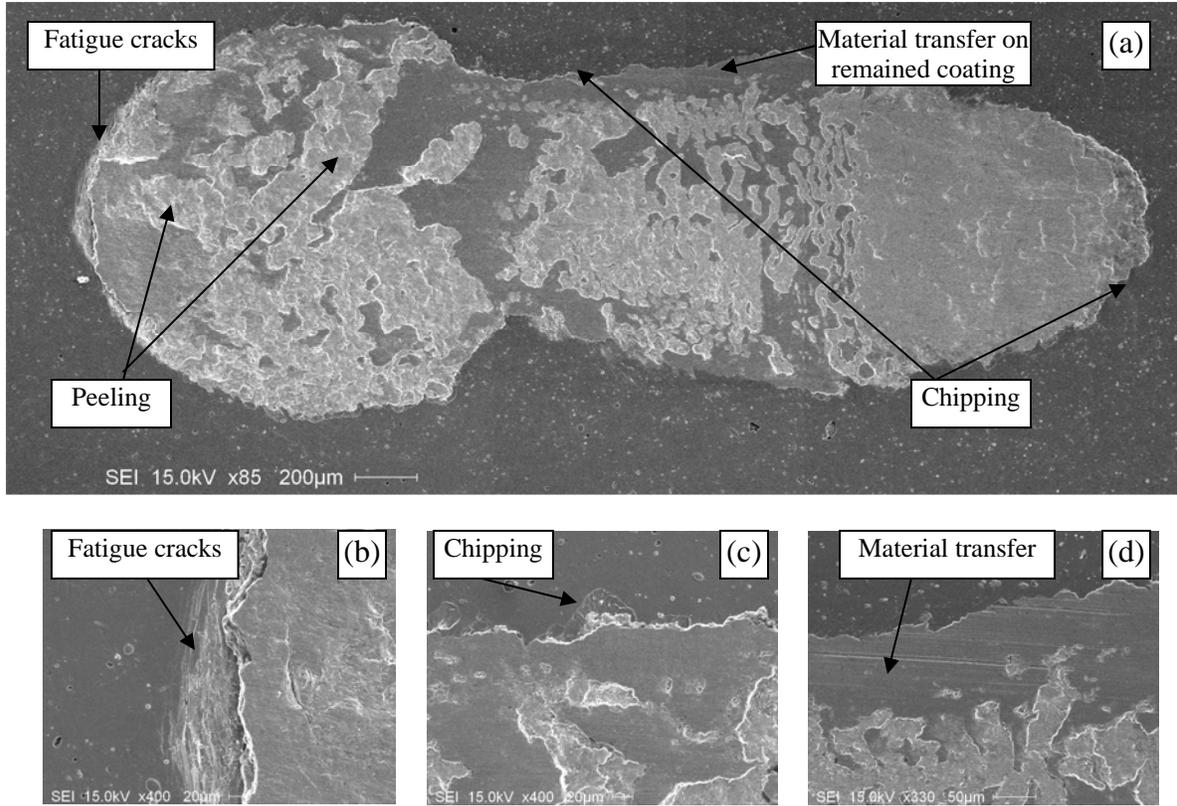
Although the hardness and elastic modulus of the B_TiAlN sample were lower in Phase II than in Phase I, B_TiAlN acted similarly to its counterpart in Phase I which showed low resistance to impact and sliding of steel ball (Figure 7) compared with A_TiAlN. Cohesive failure zones formed at the center of the crater and along the sliding track. EDX analysis also showed the material transfer from the steel ball occurred (dark area in the impact-sliding track). Fatigue cracks and chippings were found around the track (Figures 7b and 7c).

Figure 7: SEM images of the impact-sliding track of B_TiAlN after 1500 cycles
 (a) Overview; (b) local view showing fatigue cracks; (c) chipping; (d) material transfer

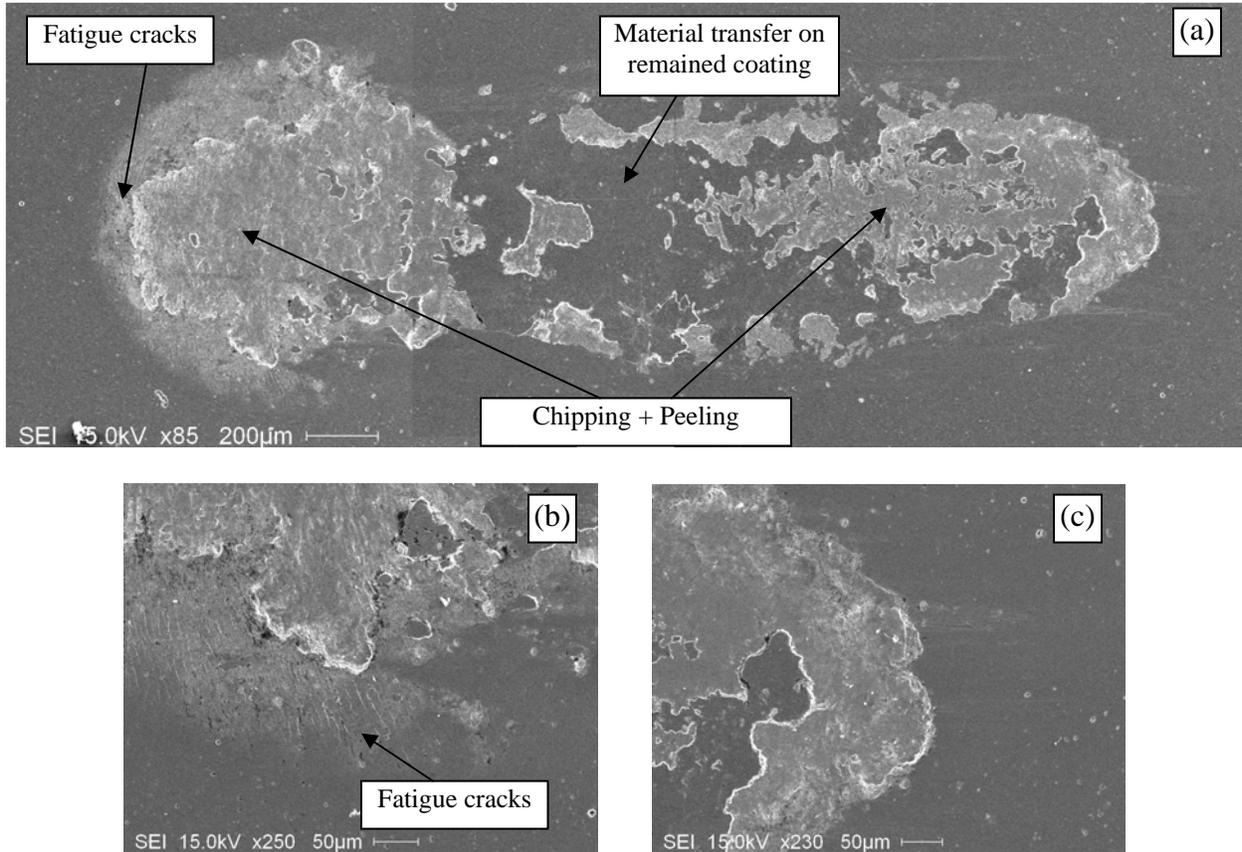
Two CrN samples tested after 1500 cycles are presented in Figure 8 and Figure 9. The coating in the crater of the A_CrN disappeared and the substrate was exposed (Figure 8a). Fatigue cracks were found around the head of the crater. The A_CrN coating material still remained in the area between the crater and the tail of the track with some Fe transferred from the steel ball. Figure 8b shows fatigue cracks around the failure area of the crater head, and Figure 8c illustrates chipping and peeling failures at the tail area of the sliding track.

Figure 8: SEM images of the impact-sliding track of A_CrN after 1500 cycles
 (a) Overview; (b) local view showing fatigue cracks; (c) tail of the track

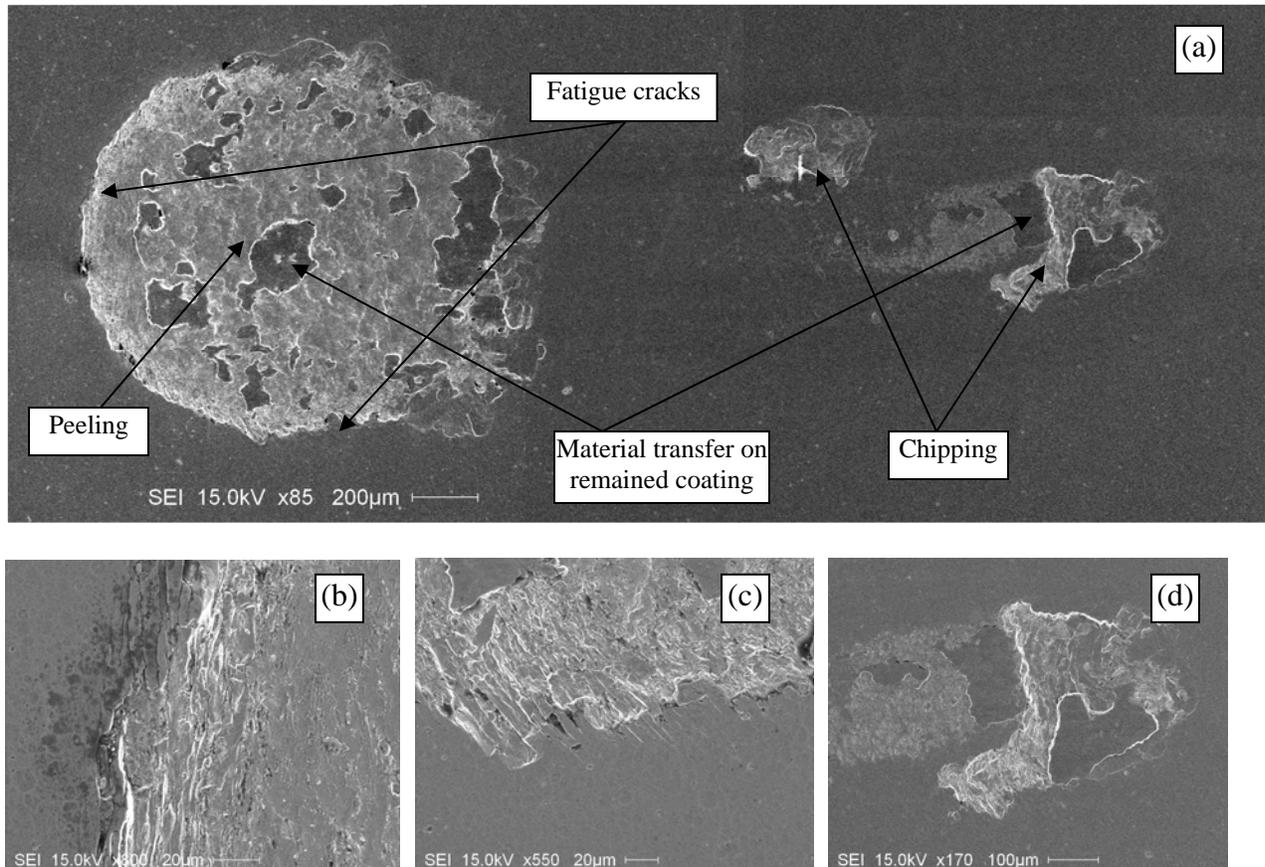
B_CrN performed better than A_CrN in the steel ball impact-sliding test. The dark areas in the crater shown in Figure 9a contained Fe transferred from the steel ball during the impact. Fatigue cracks and chipping were found at the top head of the crater (Figure 9b) and also at the middle head of the crater (Figure 9c). Although most coating materials remained in a good shape on the sliding track, it was also found that chipping occurred at both the tail and the track (Figure 9d). Material transfer from the steel ball also appeared on the surface of the remained coating in the wear track.

Figure 9: SEM images of the impact-sliding track of B_CrN after 1500 cycles
 (a) Overview; (b) local view showing fatigue cracks and peeling; (c) fatigue cracks and chipping; (d) chipping

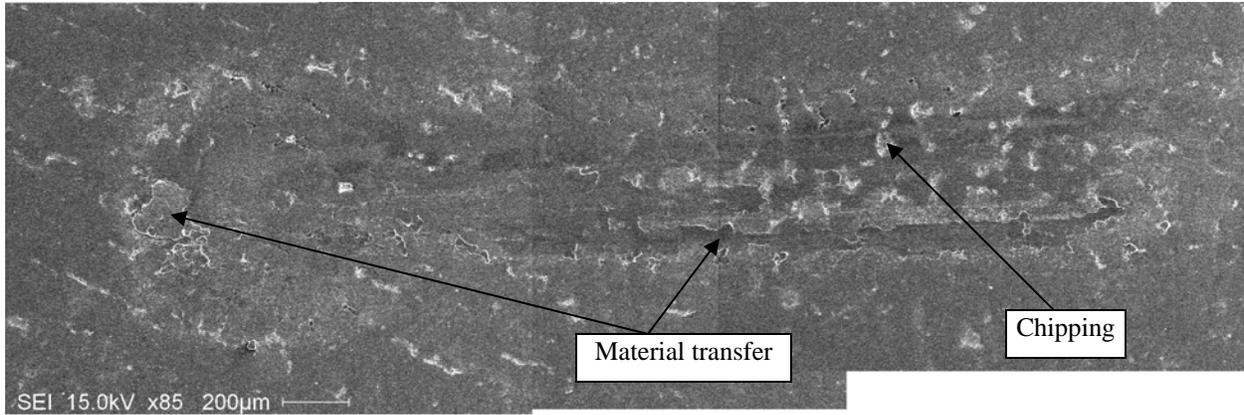
SEM images of TiC samples tested after 1500 cycles are shown in Figure 10 and Figure 11. B_TiC performed well like its counterpart in Phase I. Only material transfer and small chippings were found after the test of 1500 cycles (Figure 10). Figure 11 shows the impact-sliding track of the C_TiC coating with occurrence of localized peeling, chipping, material transferring and fatigue cracking. Material transfer occurred on the remained TiC coating and along the track.

Figure 10: SEM image of the impact-sliding track of B_TiC after 1500 cycles

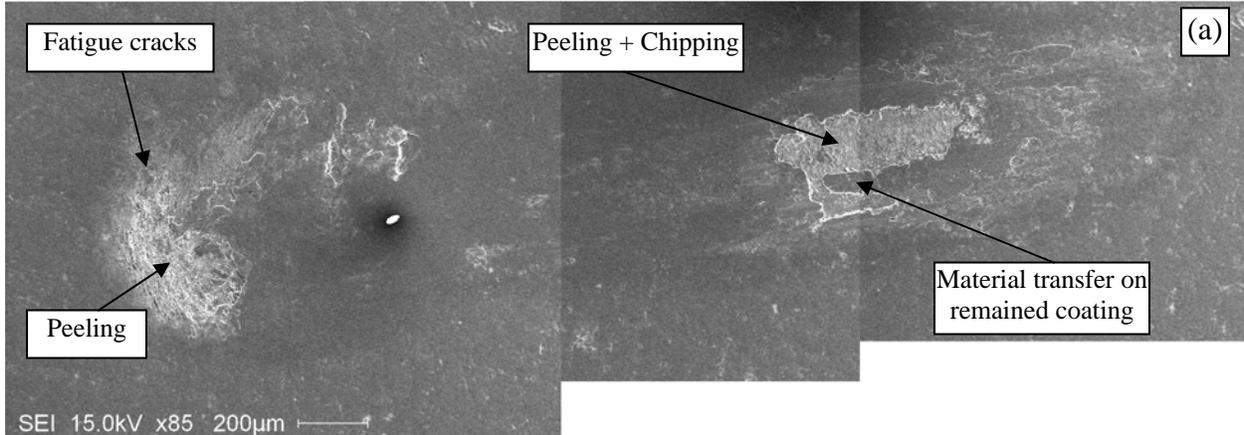
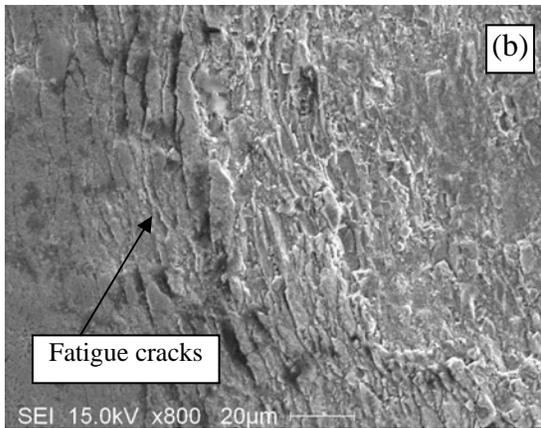
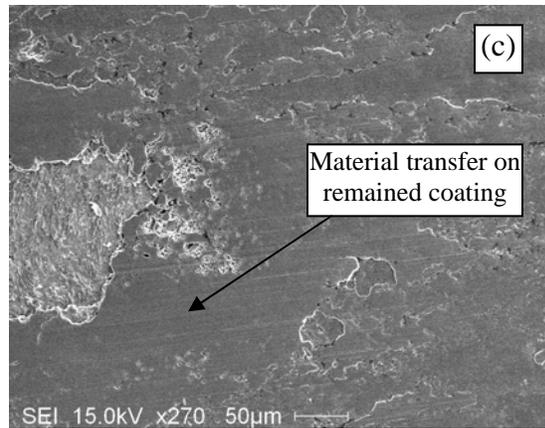
Figure 11: SEM images of the impact-sliding track of C_TiC after 1500 cycles
 (a) Overview; (b) local view showing fatigue cracks; (c) material transfer

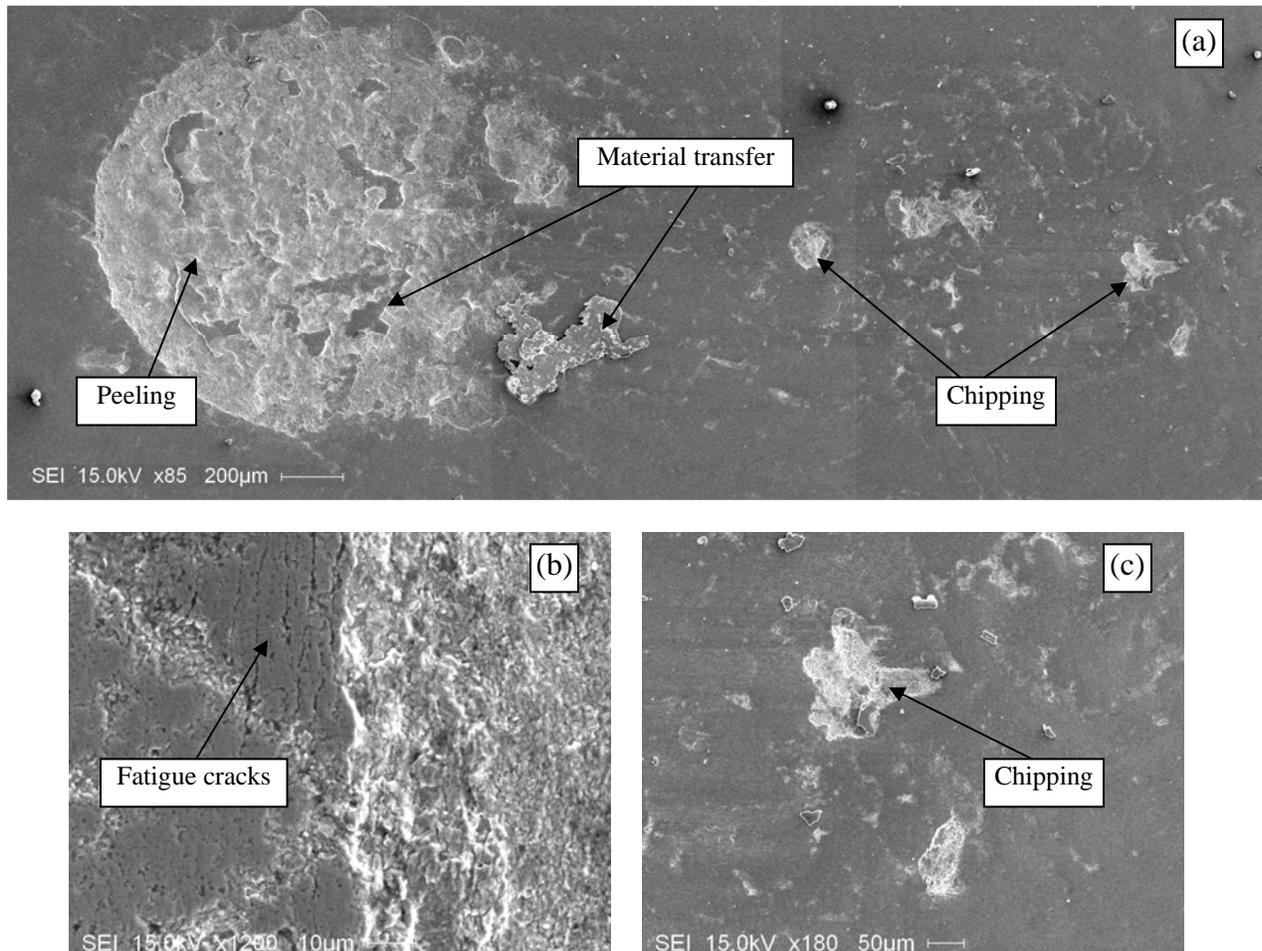
Since the B_TiC coated sample showed the least failures during the 1500 cycles' tests, an impact test up to 10000 cycles was also conducted on the sample to study the high cyclic test effect on impact fatigue of the B_TiC coating. After 10000 cycle impact test, most TiC coating materials in the crater disappeared, Figure 12a. Peeling, material transfer and fatigue cracks exhibited on the impact crater area, Figure 12b, while only chipping and material transfer were shown on the sliding track area, Figure 12c.

Figure 12: SEM images of the impact-sliding track of B_TiC after 10000 cycles
(a) Overview; (b) local view showing fatigue cracks; (c) chipping

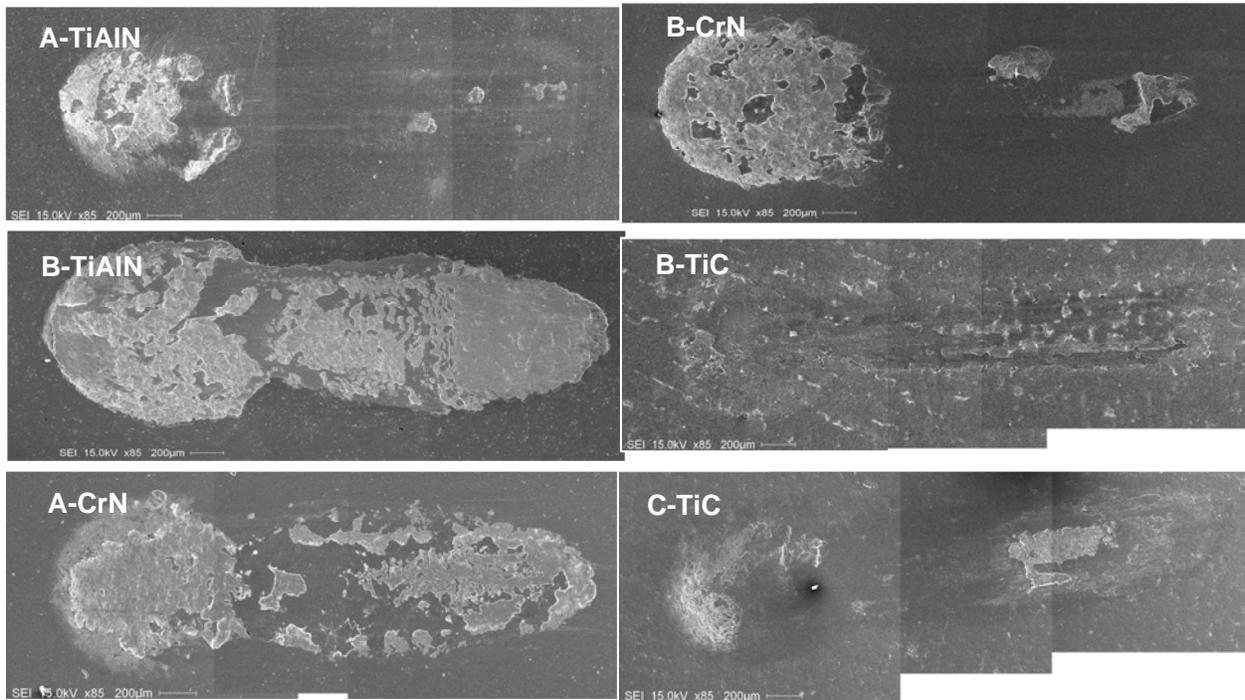
All impact-sliding tracks of six coatings are summarized in Figure 13 which shows the failure severity of different coatings in comparison. From these images, ranking their performance in the test conditions becomes possible.

Figure 13: Summary of the impact-sliding tracks of six coatings after 1500 cycles using steel balls (aspect ratio is not accurate)

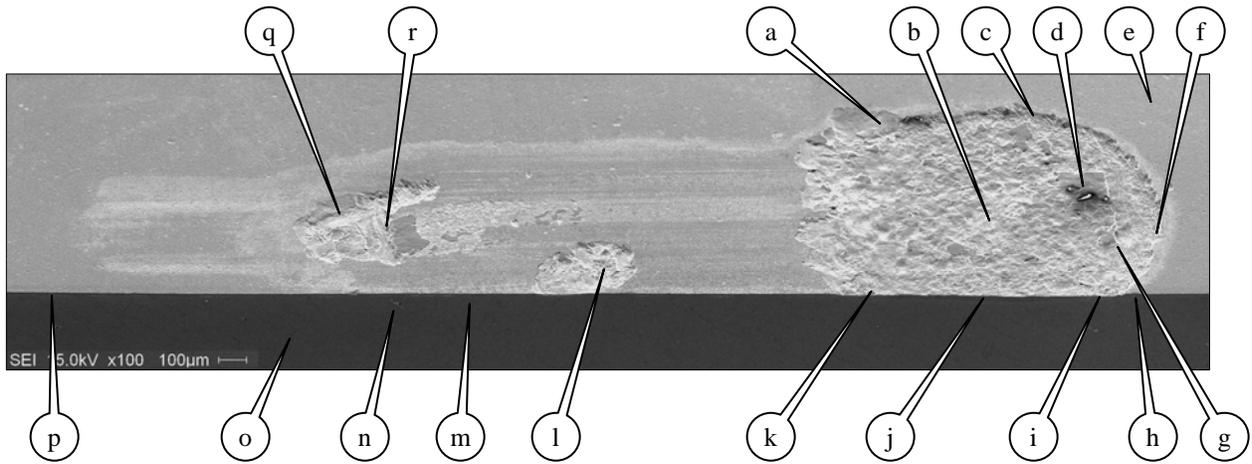
Figure 14: Overall SEM image of the cross section of the B_CrN impact-sliding track after 1500 cycles using a steel ball

Based on the information in Figure 14 and Figure 15, the failure of the B_CrN coating may follow the sequences as:

1. Fatigue cracks occurred at the center of the crater and reached the substrate during the initial stage of impact-sliding;
2. Cracked CrN coating separated from substrate piece by piece when the adjacent cracks are crossover in near horizontal directions and was brought away by abrasive wear from the center of the crater;

3. The separation of small pieces from the CrN coating propagated outward during the following cycles and formed the jagged steps around the crater except the end part of the crater;

4. At the end of the crater, shear stress began to dominate due to the sliding movement and led to both the fatigue cracks and chipping (the tail part of the crater in Figure 14);

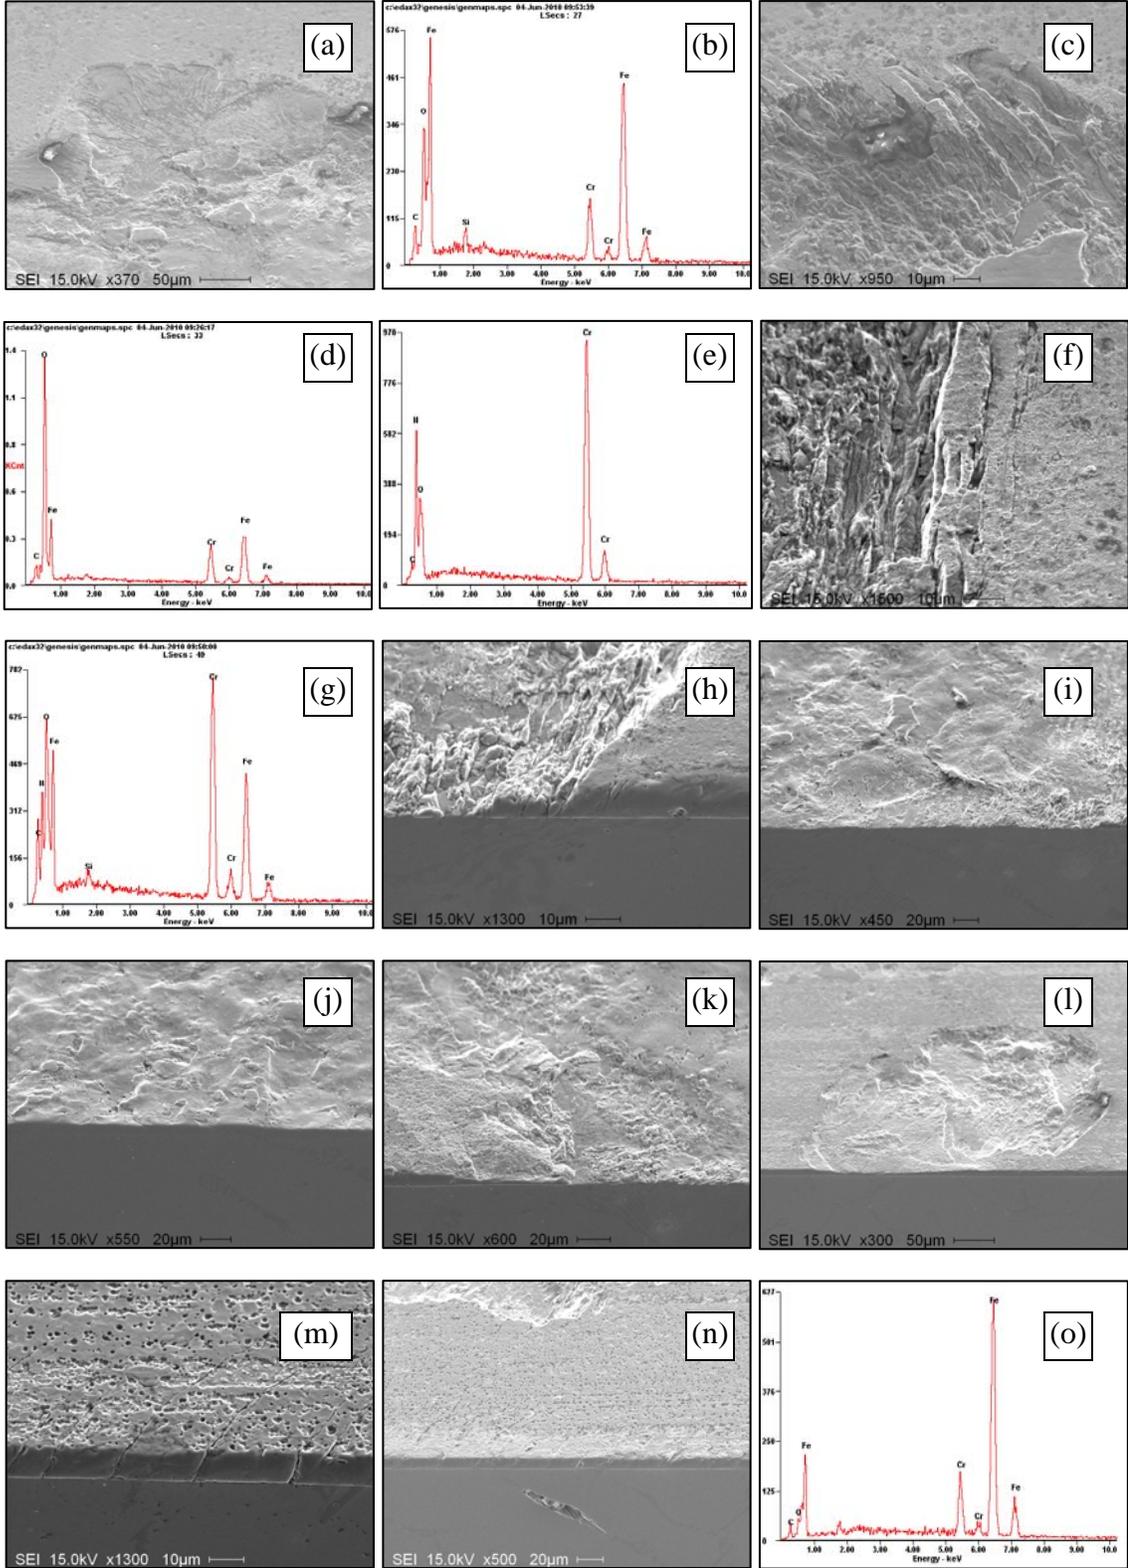
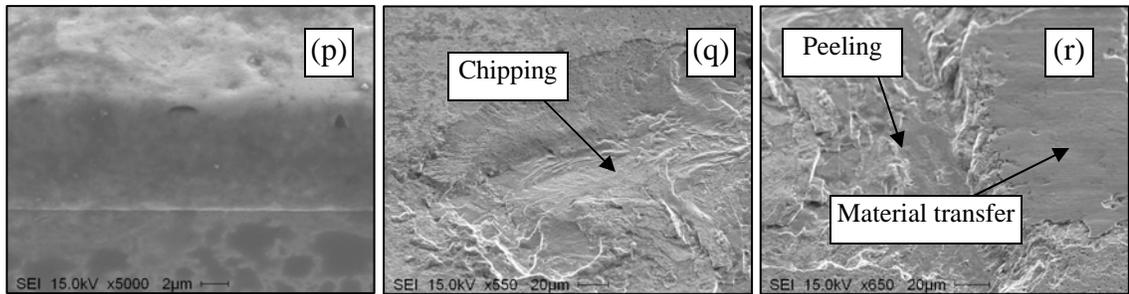
Figure 15: Local views of the cross section in Figure 14: (a) chipping at the edge of the crater; (b) EDX spectrum showing inexistence of CrN coating; (c) fatigue cracks around the crater; (d) EDX spectrum showing Fe transferred from the steel ball to the remained coating; (e) composition of the CrN coating; (f) fatigue cracks at the head of the crater; (g) EDX spectrum showing the existence of CrN coating; (h) fatigue cracks at the cross section; (i) coating remained near the head; (j) deformed substrate without coating; (k) the end of the crater; (l) chipping; (m) fatigue cracks along the impact-sliding track with a porous oxide layer which might be caused by EDM wire cutting; (n) a defect in substrate; (o) EDX spectrum showing composition of the substrate; (p) intact coating; (q) chipping at the track; (r) peeling and material transfer

5. The shear stress continued to increase due to the increasing of the pressing load (up to 200 N) during the sliding procedure and produced more chippings along the track (Figure 15l and 15q); with the increasing of the shear stress, peeling also happened (Figure 15r).

However, chipping might initiate from coating defects and not always occur right at the tail of the track, where the pressing load was the maximum (200 N) but the shear stress was low due to no inclined sliding force involved in this position.

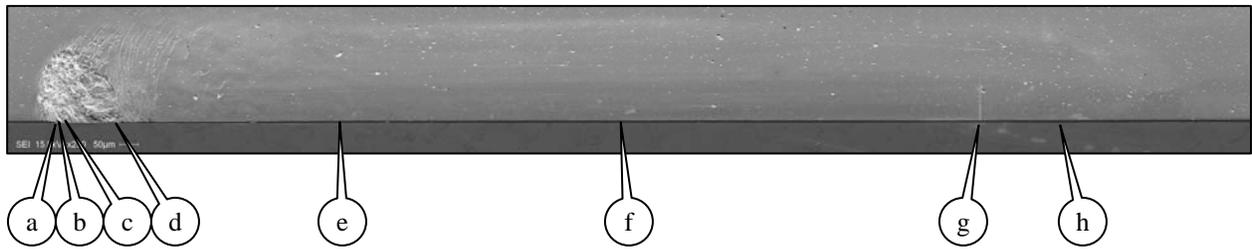
A cross section of A_TiAlN impact-sliding track was cut from the A_TiAlN coating. But this wear track was less damaged than the one shown in Figure 6. This would allow us to clearly observe coating failure processes at the interface between the coating and substrate and fatigue cracks within the coating. The cross section is presented and described in Figure 16 and Figure 17.

Figure 16: Overall SEM image of the cross section of the A_TiAlN impact-sliding track after 1500 cycles using a steel ball

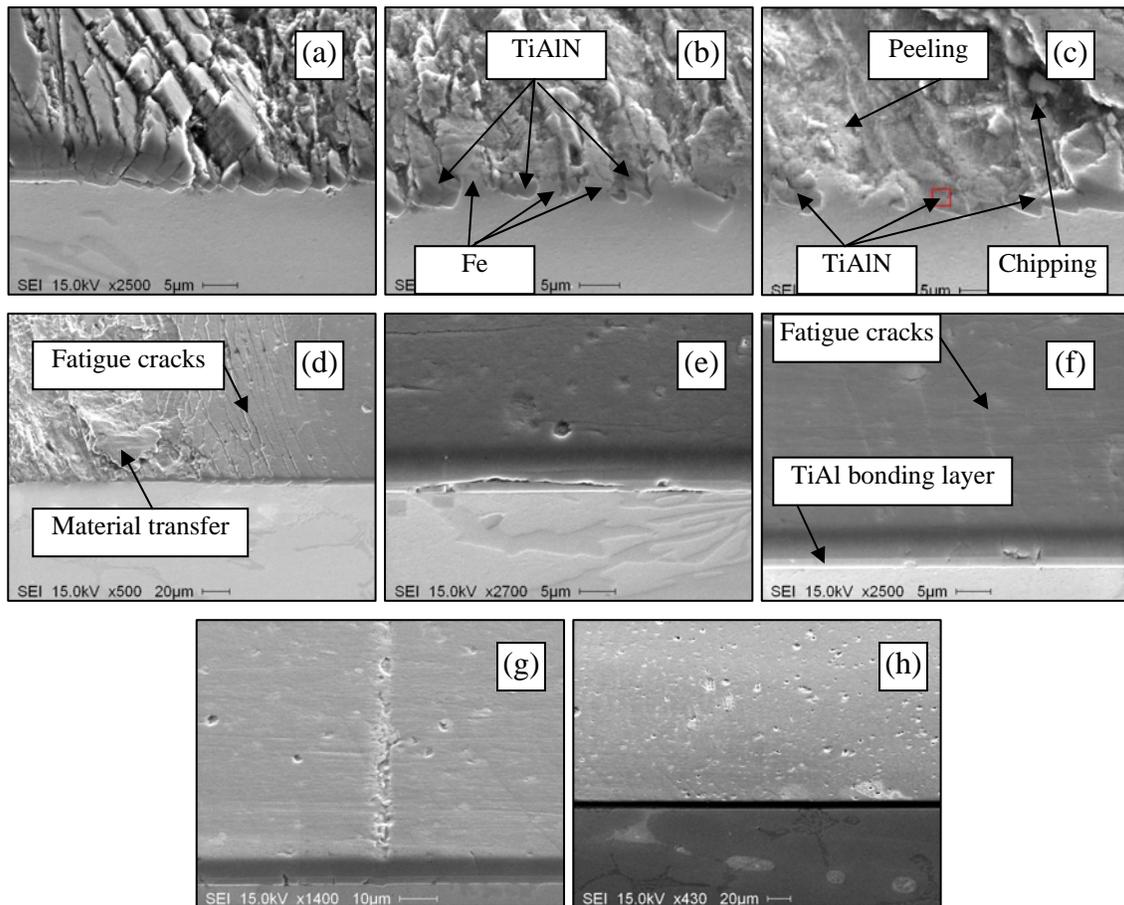
Figure 17: Local views of the cross section in Figure 16: (a) sinking of fatigue crack layers at the head of the crater; (b) interlaced TiAlN coating and Fe substrate; (c) peeling and chipping; (d) material transfer and fatigue cracks; (e) crack and debonding of TiAl interface/bonding layer, needlelike islands in substrate are Cr-rich intermetallic phase; (f) fatigue cracks at the center of the track and TiAl interface/bonding layer; (g) surface defects; (h) tail of the track showing fatigue cracks

Like B_CrN, jagged steps were found around the crater on the A_TiAlN sample. Contrary to B_CrN, cracked A_TiAlN coating pieces sunk into the substrate segment by segment (Figure 17a) and formed interlaced mixture (Figure 17b) during the impacts. Such a sinking phenomenon did not appear in B_CrN coating. Furthermore, the substrate was less exposed on A_TiAlN coating than on B_CrN coating after the tests (Figure 6 vs. Figure 9). These two different behaviors of the coatings may be explained by the fact that the A_TiAlN coating had high hardness and elastic modulus compared to B_CrN. For both of the coatings, fatigue cracks reached the substrate and spread along the entire sliding track. However, the fatigue cracking was more intense for A_TiAlN coating. Also, coating defects such as cracks in the coating bonding layer were usually related to the underlying Cr-rich intermetallic phase (Figure 17e). This phenomenon was found in all the three coatings.

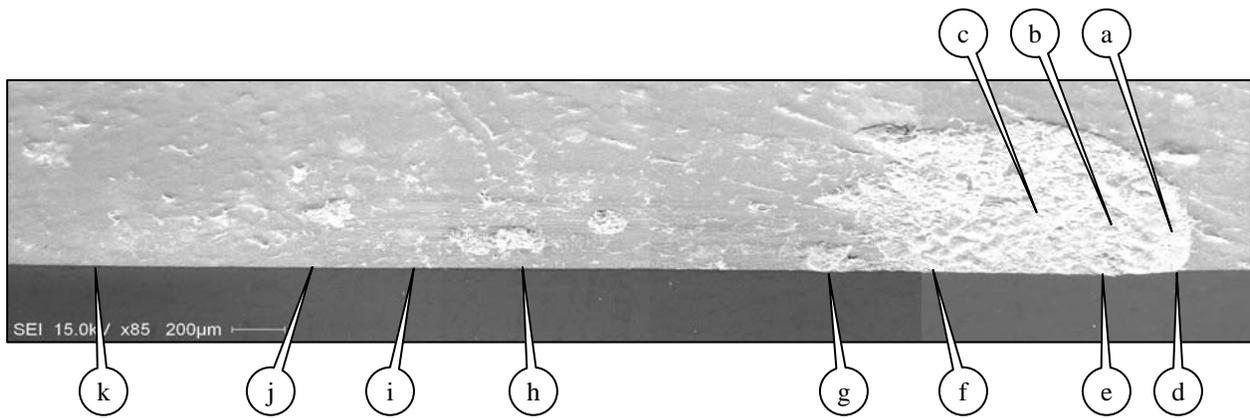
B_TiC under the 1500 cycles' impact-sliding showed no severe failures. Therefore, the track of B_TiC tested with 10000 cycles was cut and presented and described in Figure 18 and Figure 19.

Figure 18: Overall SEM image of the cross section of the B_TiC impact-sliding track after 10000 cycles using a steel ball

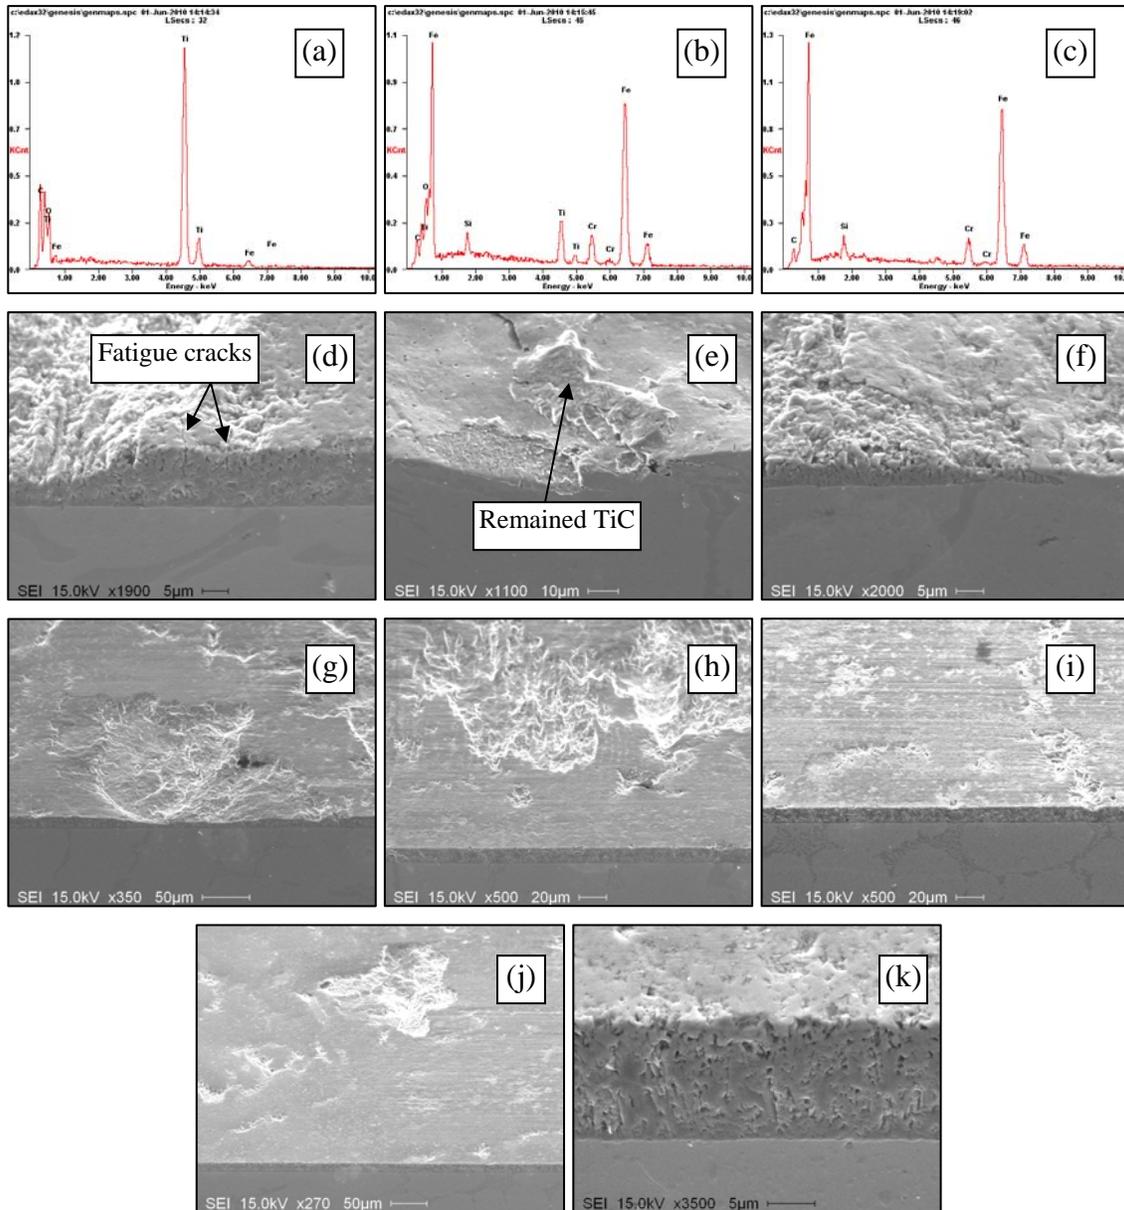
Figure 19: Local views of the cross section in Figure 18: (a) EDX spectrum showing the dominance of TiC with little amount of Fe transferred from the steel ball; (b) EDX spectrum showing that Fe from the substrate dominated and TiC still existed; (c) EDX spectrum showing nonexistence of TiC ; (d) SEM image showing fatigue cracks stopped in the middle of the coating; (e) remained TiC coating at the center of the crater; (f) end of the crater showing sinking of the coating; (g) chipping; (h) chipping; (i) surface defects and underlying Cr-rich intermetallic phase; (j) scratches and chipping at the tail of the track; (k) cross section of intact coating showing the porous structure of the CVD B_TiC coating

The porous structure of the CVD B_TiC coating seemed to contribute to the best performance among the three coatings. Only small chippings and material transfer occurred after impacts of 1500 cycles. The cross section of the coating after 10000 cycles' test shows that the propagation of fatigue cracks might be

stopped by small holes in the coating. With the increasing of impact cycles, abrasive wear occurred and the coating disappeared at the center of the crater. Similar to the other two coating samples, chipping appeared from the crater to the end of the track. Again, the defects shown in bright areas of Figure 19i might be caused by the interaction of the Cr-rich intermetallic phases and coating materials during the coating fabrication process.
