Great Designs in

STEEL

Delayed Cracking of Advanced High Strength Steel Solutions

A/SP Steel Testing Harmonization Task Force

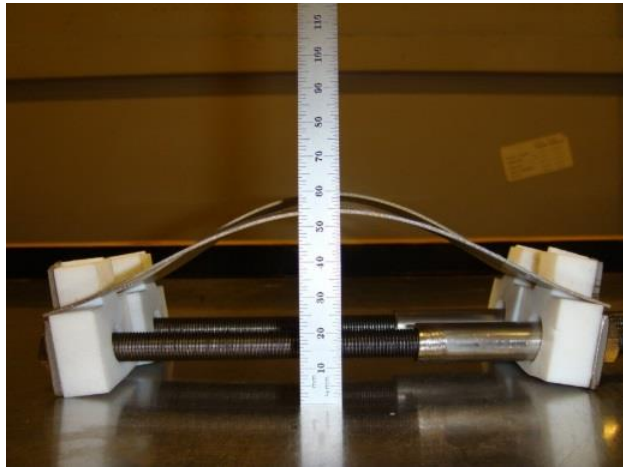
Test Sample Geometry

- Samples are strain-gauged and bent to the desired stress levels
- Fixtured samples are immersed in 0.1 N hydrochloric acid

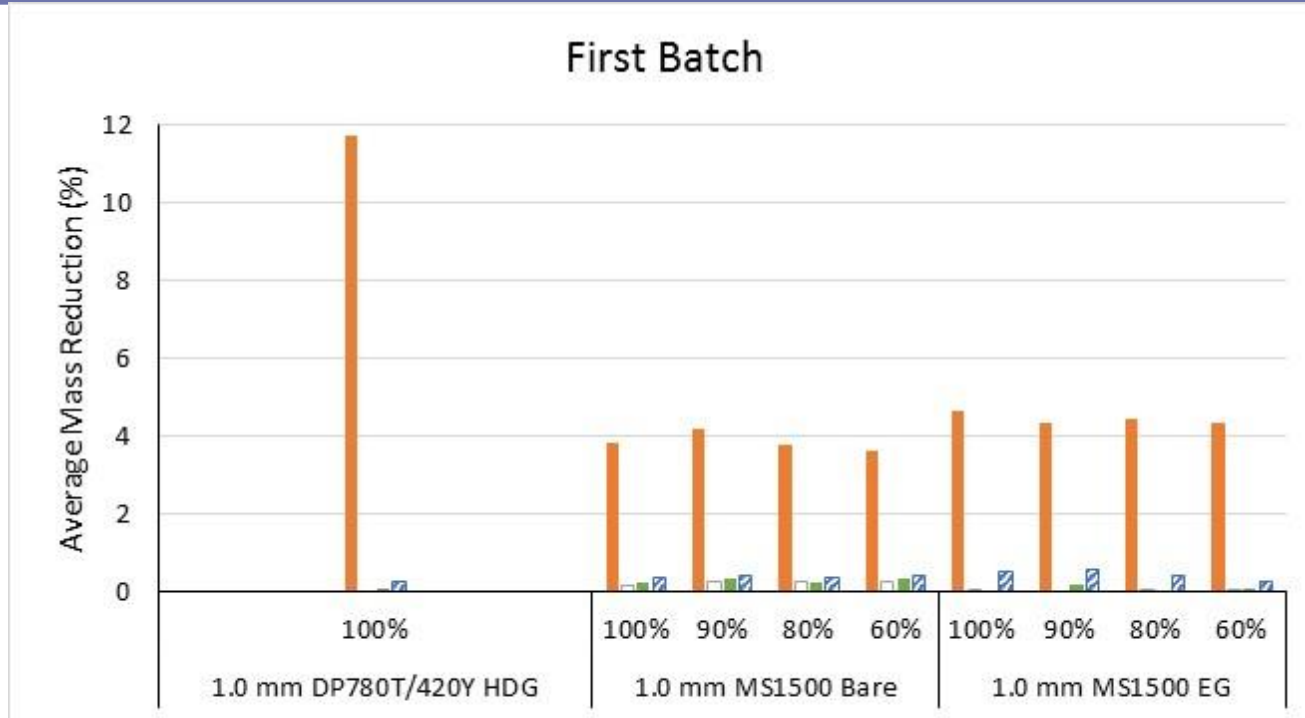
Average Mass Reduction (%) – First Batch

Material	Solution	Initial pH	% of Yield Strength Tested	Total Specimens	Number of Specimens Cracked
1.0mm DP780T/420Y HDGI	0.1N HCL	1.04	100%	3	0
	0.1% NH ₄ SCN	5.60	100%	3	0
	0.3% NH ₄ SCN	5.50	100%	3	0
	1.0% NH ₄ SCN	6.06	100%	3	0
1.0mm MS1500 Bare	0.1N HCL	1.00	100%, 90%, 80%, 60%	12	0
	0.1% NH ₄ SCN	6.73	100%, 90%, 80%, 60%	12	0
	0.3% NH ₄ SCN	5.40	100%, 90%, 80%, 60%	12	12
	1.0% NH ₄ SCN	5.57	100%, 90%, 80%, 60%	12	11
1.0 mm MS 1500 EG	0.1N HCL	1.08	100%, 90%, 80%, 60%	12	11
	0.1% NH ₄ SCN	5.73	100%, 90%, 80%, 60%	12	10
	0.3% NH ₄ SCN	5.38	100%, 90%, 80%, 60%	12	12
	1.0% NH ₄ SCN	5.86	100%, 90%, 80%, 60%	12	12

■ 0.1N HCL
 ■ 0.1% NH4SCN
 ■ 0.3% NH4SCN
 ■ 1.0% NH4SCN

- Use of NH_4SCN resulted in a significantly lower attack on the coatings than the previously used HCl
- The lower rate of attack on the zinc coatings in the NH_4SCN solutions (ie low mass loss), likely resulted in low/little hydrogen evolution and lower amounts of hydrogen absorption

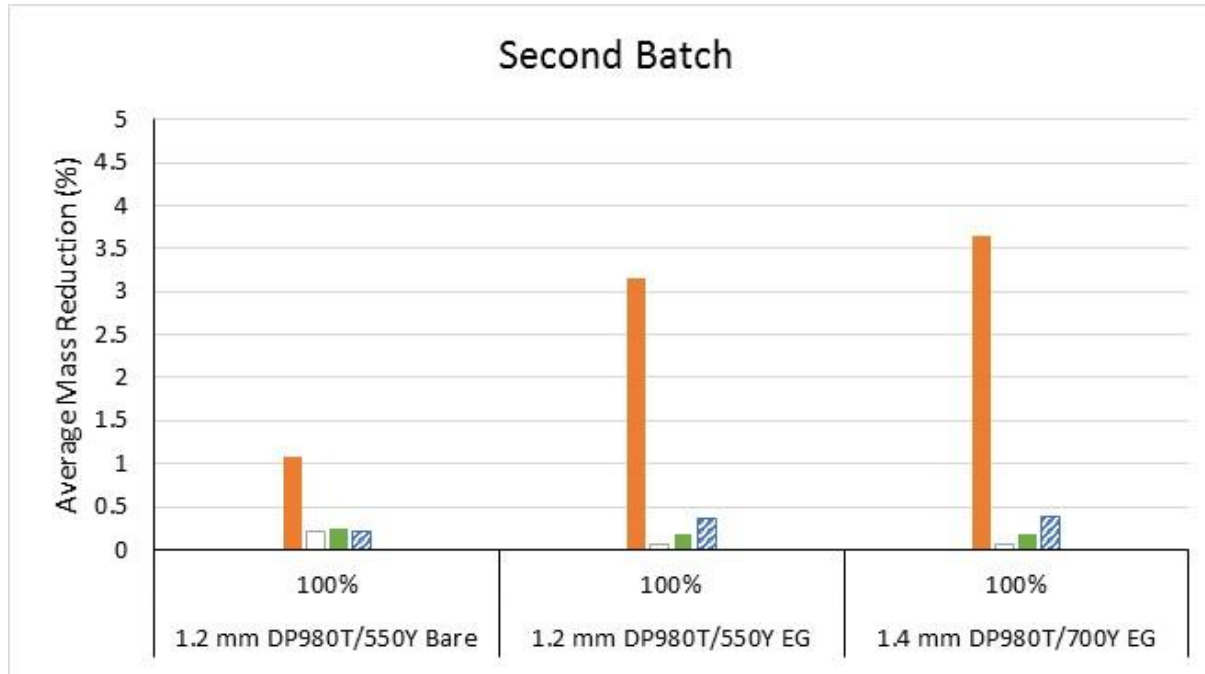
Average Mass Reduction (%) – Second Batch

Material	Solution	Initial pH	% of Yield Strength Tested	Total Specimens	Number of Specimens Cracked
1.2mm DP980T/550Y Bare	0.1N HCL	1.05	100%	3	0
	0.1% NH ₄ SCN	5.52	100%	3	0
	0.3% NH ₄ SCN	5.42	100%	3	0
	1.0% NH ₄ SCN	5.09	100%	3	0
1.2mm DP980T/550Y EG	0.1N HCL	1.05	100%	3	0
	0.1% NH ₄ SCN	5.48	100%	3	0
	0.3% NH ₄ SCN	5.36	100%	3	0
	1.0% NH ₄ SCN	5.04	100%	3	1
1.2mm DP980T/700Y EG	0.1N HCL	1.04	100%	3	0
	0.1% NH ₄ SCN	5.48	100%	3	0
	0.3% NH ₄ SCN	5.37	100%	3	0
	1.0% NH ₄ SCN	5.04	100%	3	0
